ENCLOSURE 3

QUARTERS 14 REHABILITATION DESIGN PRESENTATION

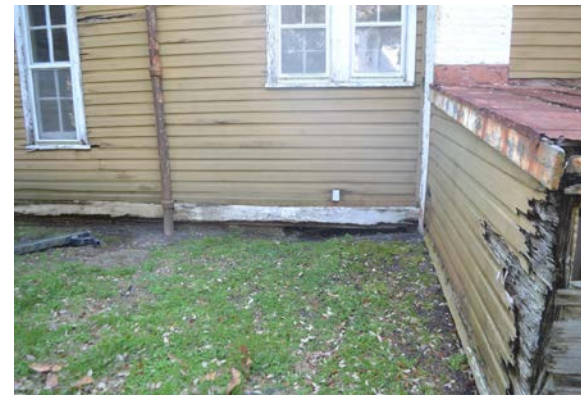
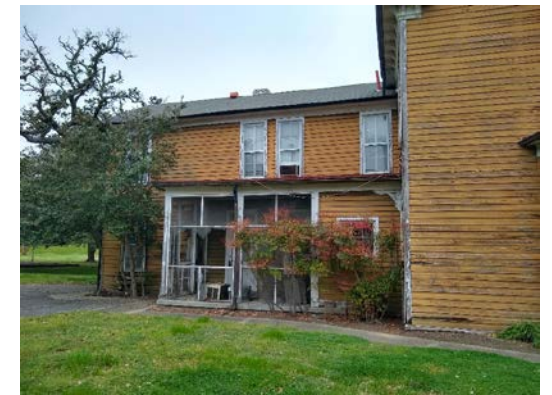
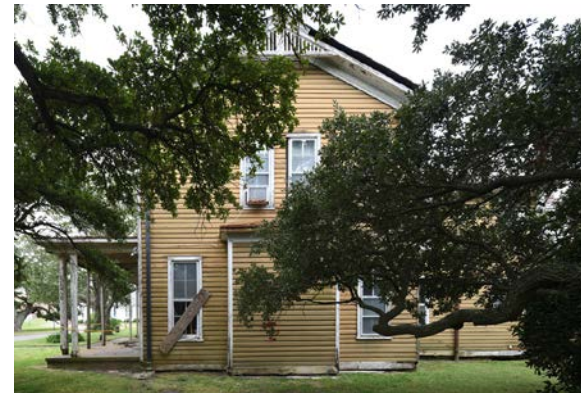
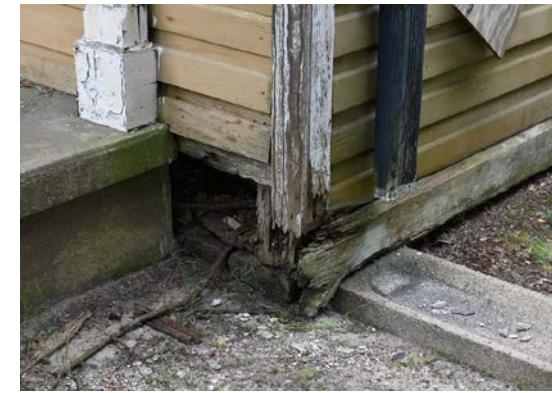
Quarters 14 rests on a brick masonry foundation and over time, the surrounding grade has been elevated and the wood sills are now in contact with grade at numerous locations. This has resulted in an extensive amount of deterioration and termite damage to the skirt boards, the structural sills and to the bottom of the exterior wall framing.

Current conditions of the grade against Quarters 14

To remedy this situation and pursuant to the NPS *Guidelines on Flood Adaptation for Rehabilitating Historic Buildings*, we have proposing to raise Quarters 14 by 6 courses of masonry constructed on the original foundation wall. This will raise the framing to be above-grade and will keep the first-floor elevation in similar context to the adjacent historic structures Buildings 15, 62 and 63, thus minimally impacting the structures association as well as the historic setting.

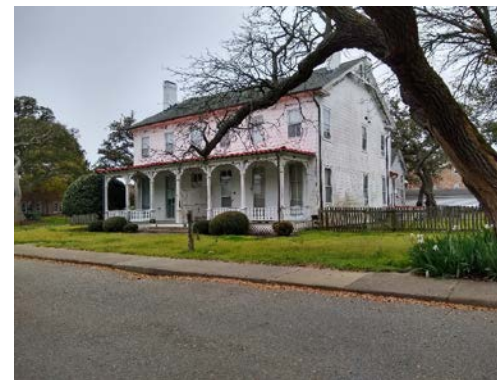
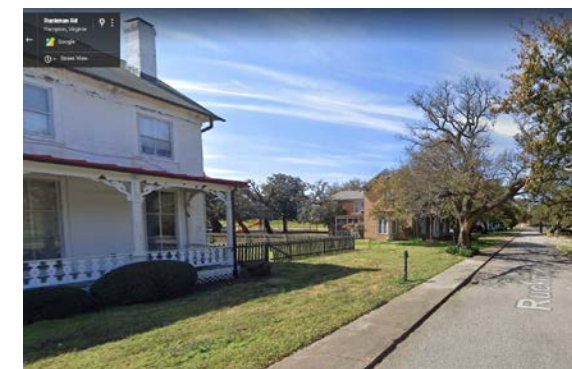
Quarters 15 and the relationship of the first-floor levels between 15 and 14.

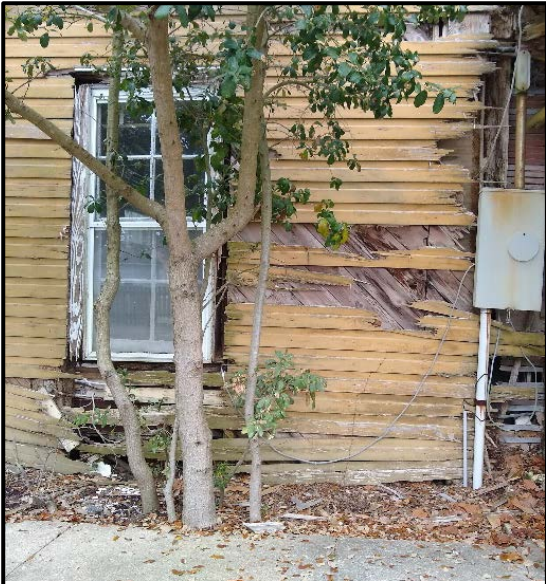
Mechanical room and chimney proposed to be removed

- Remove, mechanical room and chimney, repair siding

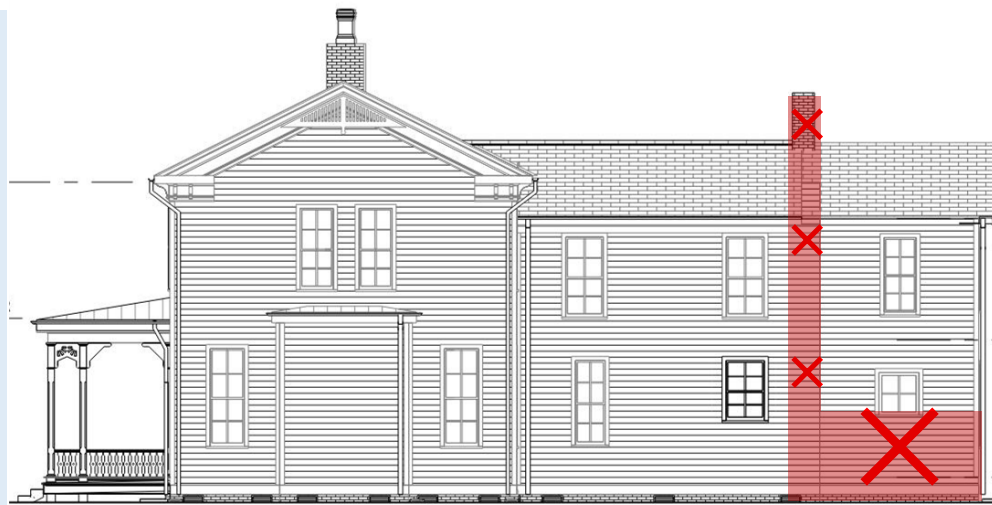
NORTH ELEVATION

North Elevation Significant Features: Chimneys and Chimney pots, cornice with brackets, decorative fretwork at the gable-ends

- Retain and repair to the greatest extent possible the above-mentioned significant features
- Remove boiler flue and below-grade mechanical shed (ca 1940)

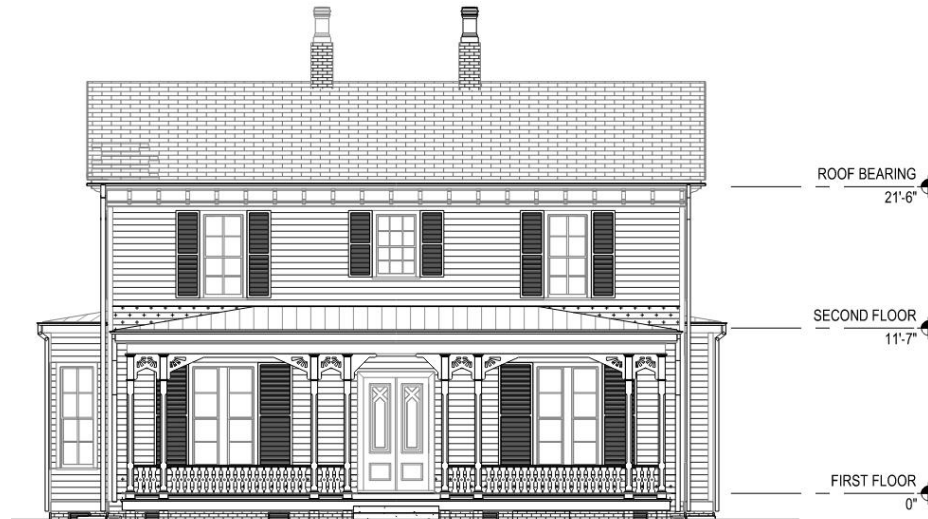
EAST ELEVATION

East Elevation Significant Features: Chimneys and pots, cornice with brackets, porch (Columns/brackets/rails missing)

- Repair chimneys
- Replicate the north chimney pot and install
- Retain and repair cornice and brackets
- Reconstruct front porch (columns, rails, brackets, roof)
- Replace the concrete porch floor with wood tongue and groove boards
- Re-locate bathroom vent so that it is not visible on principal facade

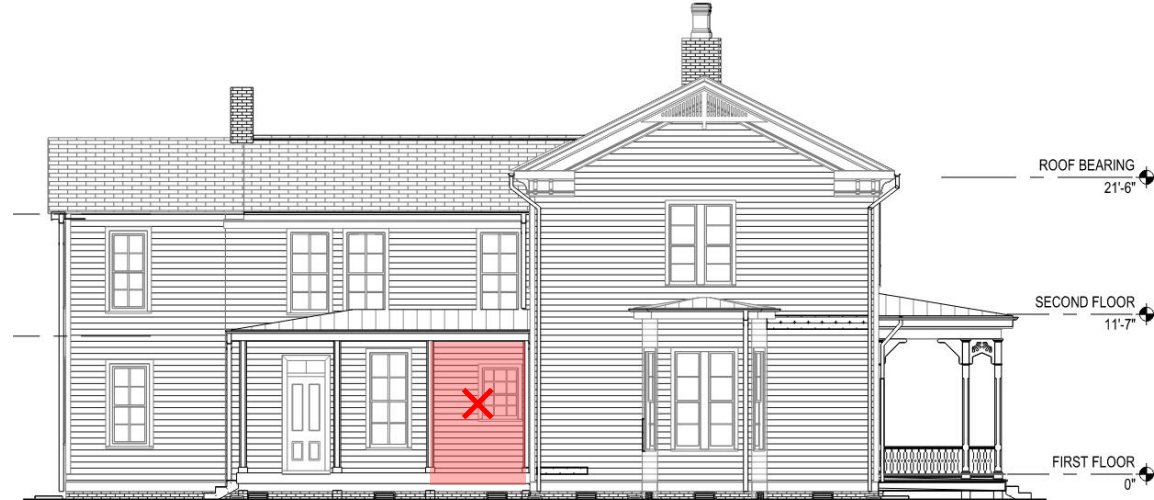
SOUTH ELEVATION

South Elevation Significant Features: Porch, porch brackets, kitchen door, decorative gable bracket

- Remove storage room infill at side porch, return to original configuration
- New screening at side porch
- New wood porch brackets (using an existing bracket as a template)
- Re-locate electrical service entrance
- Retain and repair bead board porch ceiling
- Repair/refinish gable fretwork
- Replace concrete porch floor with wood tongue and groove porch
